STRENGTHENING AND HERITAGE RESTORATION OF THE ARTS CENTRE OF CHRISTCHURCH

John Trowsdale¹, Peter Carney², Alistair Boys³.

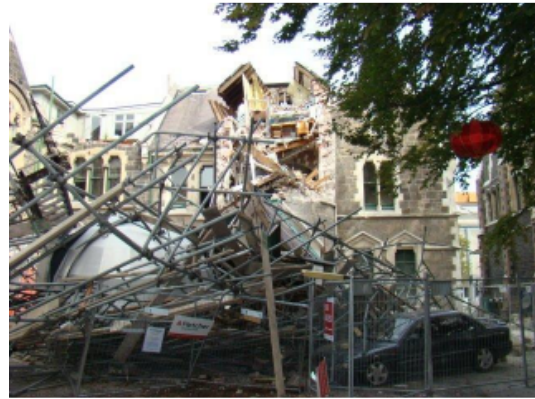
The February 2011 event had a significantly different outcome. Building stability across the entire site was severely reduced with a number of building elements suffering partial collapse, most notably the Observatory Tower (see Photograph 1 below). Following initial assessments and reactive

Photograph 1: Collapse of the Observatory building

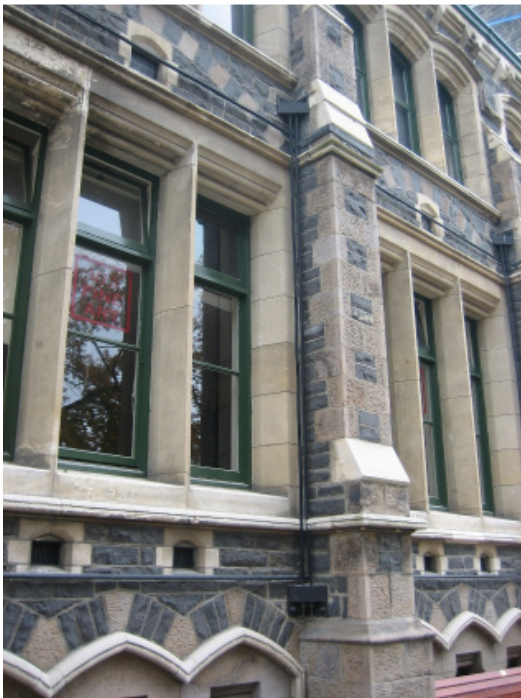
The Chemistry building used both vertical and horizontal strands primarily to add flexural capacity to the buttress (column) and spandrel (beam) arrangement along the north and south elevations. Anchored externally, as shown in Photograph 2 below, paired strands run from below the elevated ground floor to above first floor levels at the re-entrant corner of the buttress and spandrel panels. The horizontal strands at each floor plate are paired internally and externally.

Photograph 2: External post-tensioning to Chemistry building

Throughout the Canterbury earthquakes these elements performed well and significantly limited the extent of damage sustained by the building. Notable for both the Chemistry and College Hall

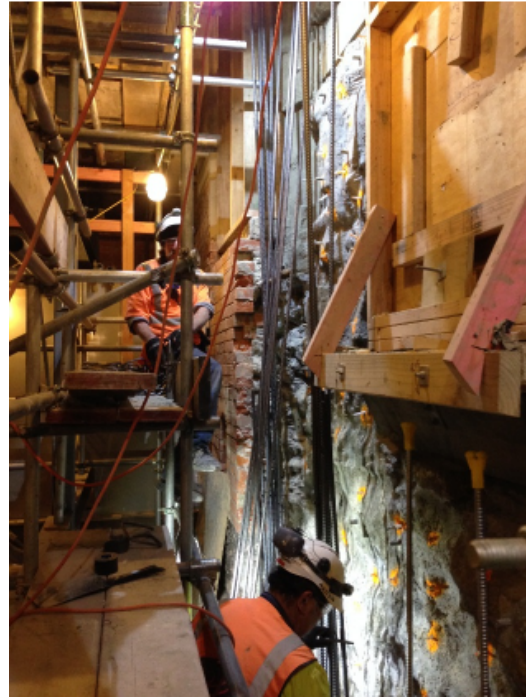
Photograph 3: Clock Tower internal concrete skin wall within existing geometry

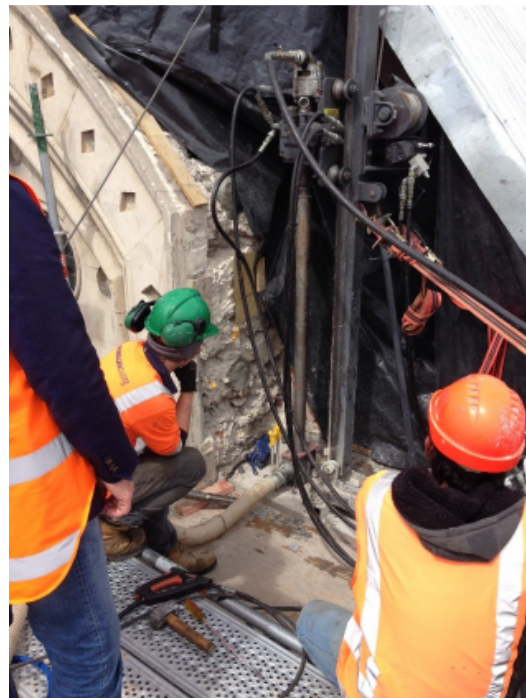
Photograph 4: College Hall downhill core drilling for post-tensioned bars
